## **Pipeline Group Factual Report**

#### **Stork Draft HA-DM 12" Joints Exam plus Inspection Data**

Report No. 0270-07-17309

Testing and Examination of Pipe from  
Dixie Pipeline Company's  
12-inch Hattiesburg, MS to Demopolis, AL Pipeline

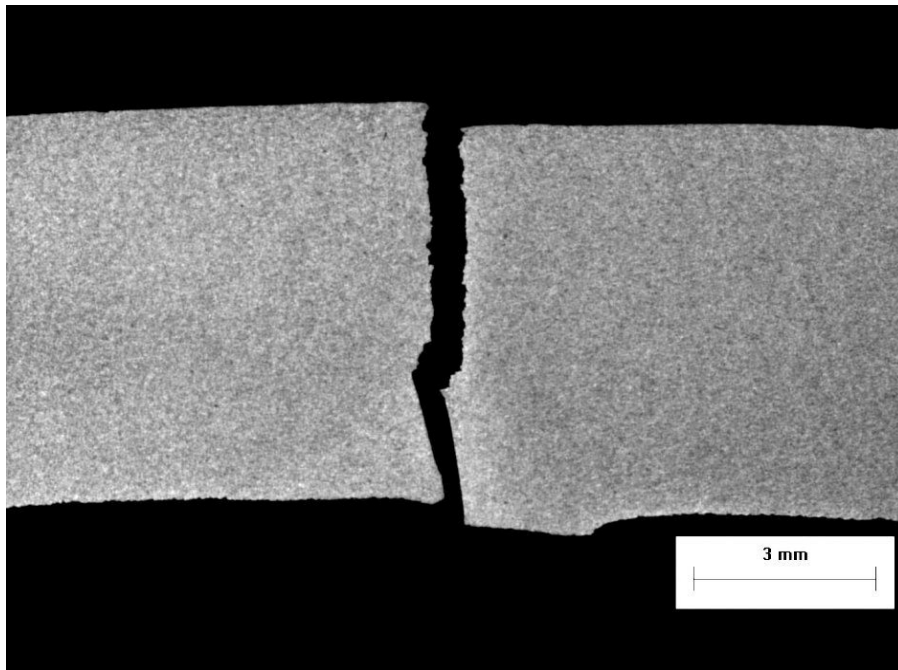
Joint No. 6105

The fracture initiated at a hook crack on the inside surface, which is shown in Figure 5. The hook crack was approximately three inches long, and at its deepest was 0.13 inch deep, which is 49 percent of the wall thickness. Other hook cracks were evident along the length of the fracture, separated by brittle fractures. The hook cracks were located near each surface and near midwall. One of the hook cracks, shown in Figure 6, was at the reported USCD indication. Figure 7 shows a typical hook crack upstream of the fracture origin.

Typical hook cracks upstream from the failure origin.

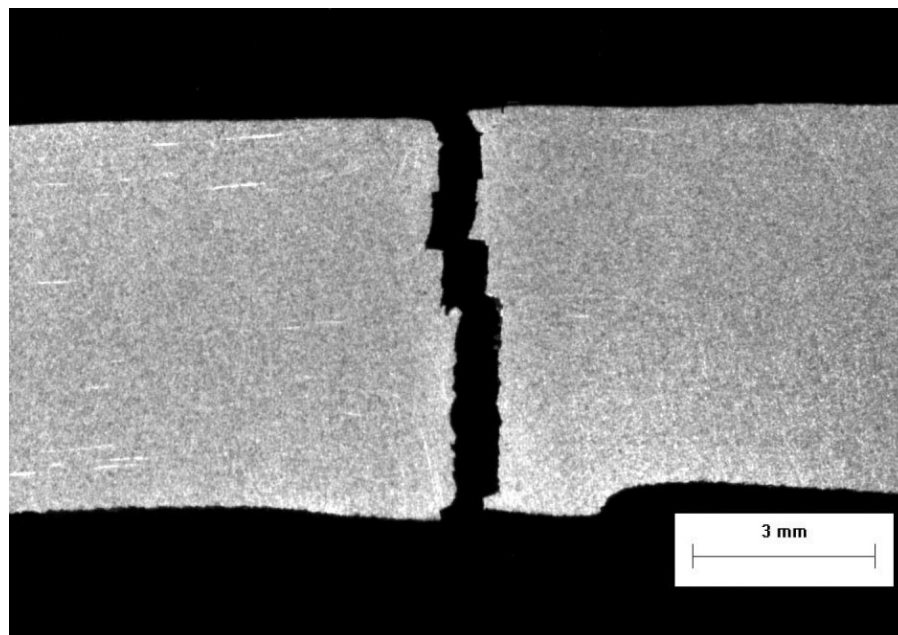
Figure 8                      Joint No. 6105                      8X  
Nital Etch

Matching transverse sections from the hook crack shown in Figure 5.

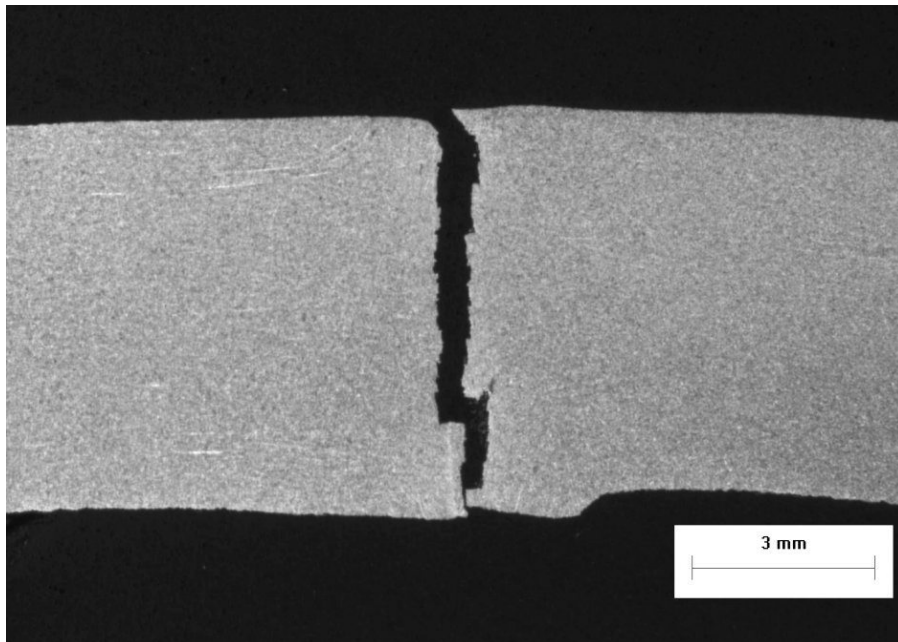
Figure 9                      Joint No. 6105                      8X  
Nital Etch

Matching transverse sections from the hook crack shown in Figure 6.

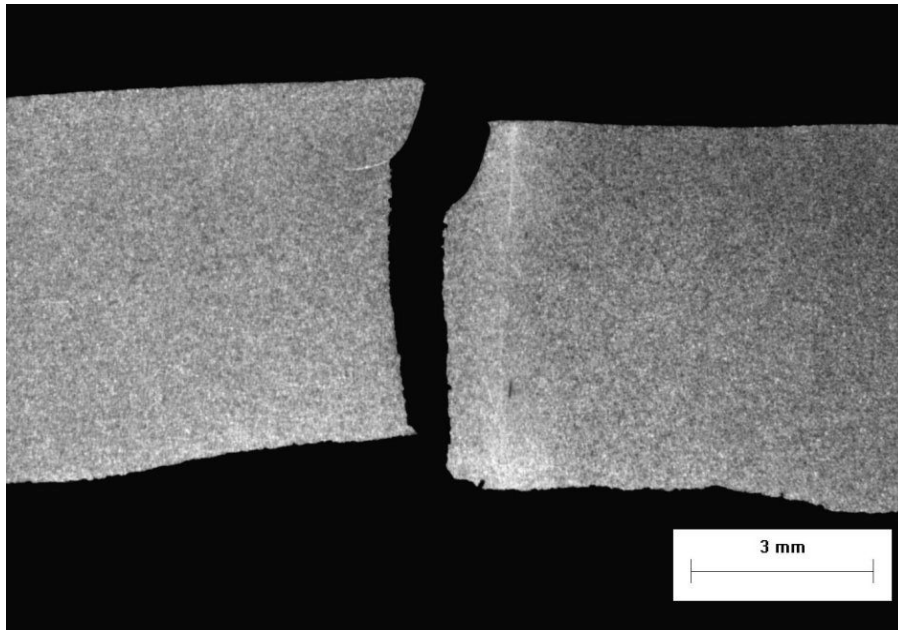
Joint No. 2797

No fracture origin was apparent on the fracture surfaces. The most prominent flaw was a hook crack on the outside surface that extended for several inches, and was deepest at 12 feet, 4 inches, as shown in Figure 15. (Note that in Figures 15 through 17 the outside surface is at bottom.) Other hook cracks were apparent along the length of the fracture as well as black spots. Many of the black spots were located in the length of the reported USCD indication, some of which are shown in Figures 16 and 17. The deepest flaw found along the fracture is indicated by the arrow in Figure 17; it was 0.19 inch deep or 79 percent of the measured wall thickness.

Photographs showing typical black spots on the outside surface (at bottom). The arrow in Figure 17 indicates the deepest flaw.

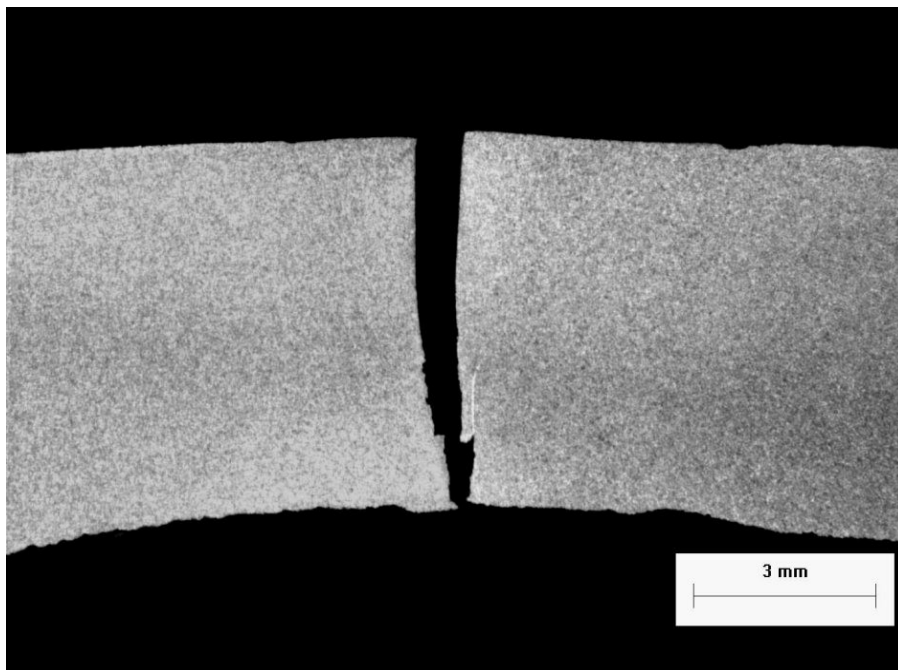
Figure 19      Joint No. 2797      25X  
Hot Picric Acid Etch

Figure 18 shows matching transverse sections from the hook crack, and Figure 19 shows the hook crack etched with hot picric acid, with an arrow indicating the weld line. Figure 20 shows the matching transverse sections from the black spot shown in Figure 17. The surfaces of the black spot were flat and straight, as shown in Figure 21, but beyond the black spot the surface was irregular, as shown in Figure 22. The flat surfaces along the black spot were never fused, whereas the irregular surfaces represent fractures of previously fused metal.

Outside surface of the hook crack after etching. The arrow indicates the weld line.

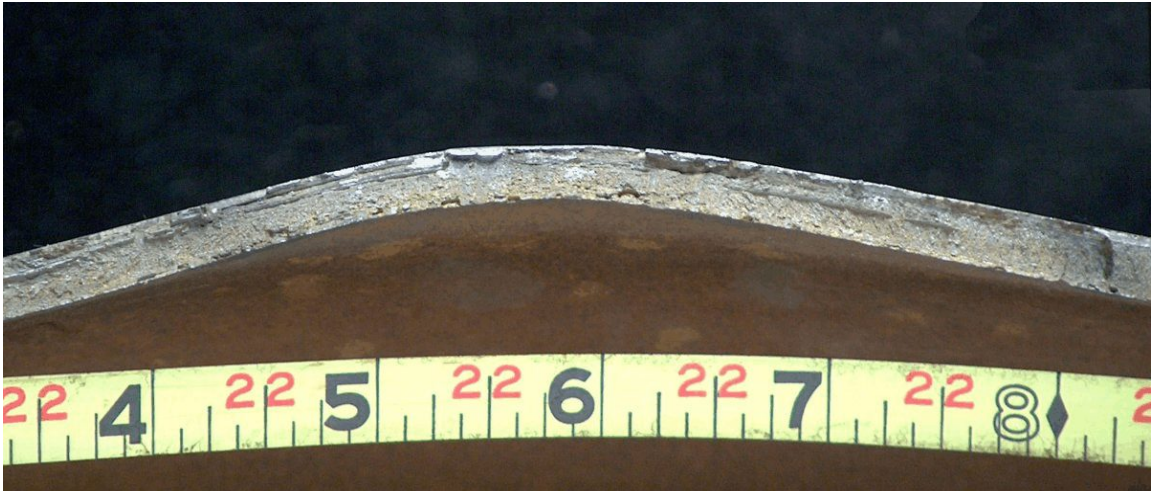
Joint No. 324

Figure 23 shows the rupture in Joint No. 324, which extended from 20 feet, 5 inches to 37 feet. There was one USCD indication 2-1/2 inches long reported along the fracture length, at 22 feet, 6 inches. The reported indication coincided with the apparent fracture origin at a hook crack on the outside surface, shown in Figure 24. In addition to a bulge, chevron patterns (not included in Figure 24) could be seen on each side of the hook crack, pointing to it as the failure origin. The maximum depth of the hook crack was approximately 0.10 inch, which was 37 percent of the measured wall thickness.

Photograph showing the rupture in Joint No. 324.

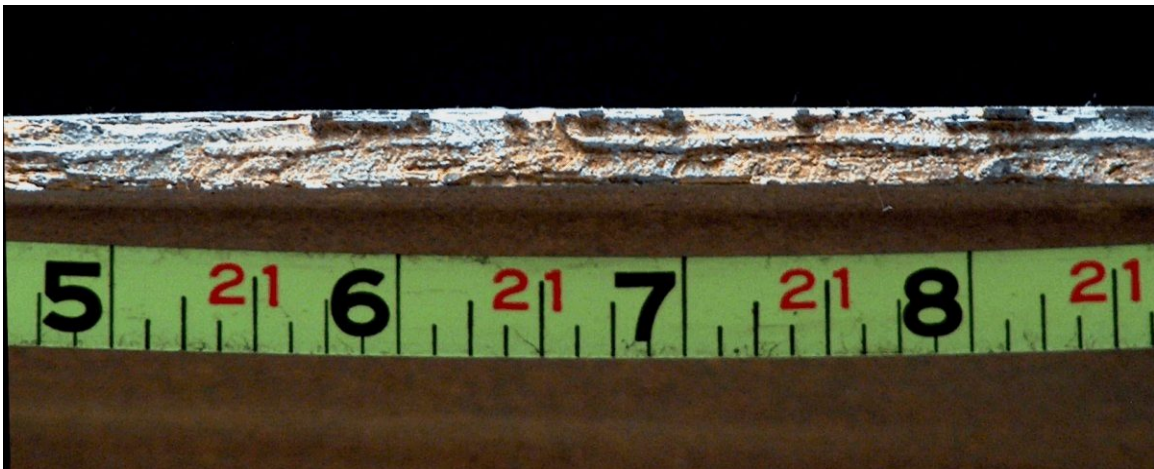
Figure 24

Photograph showing a hook crack at the outside surface at the apparent origin.

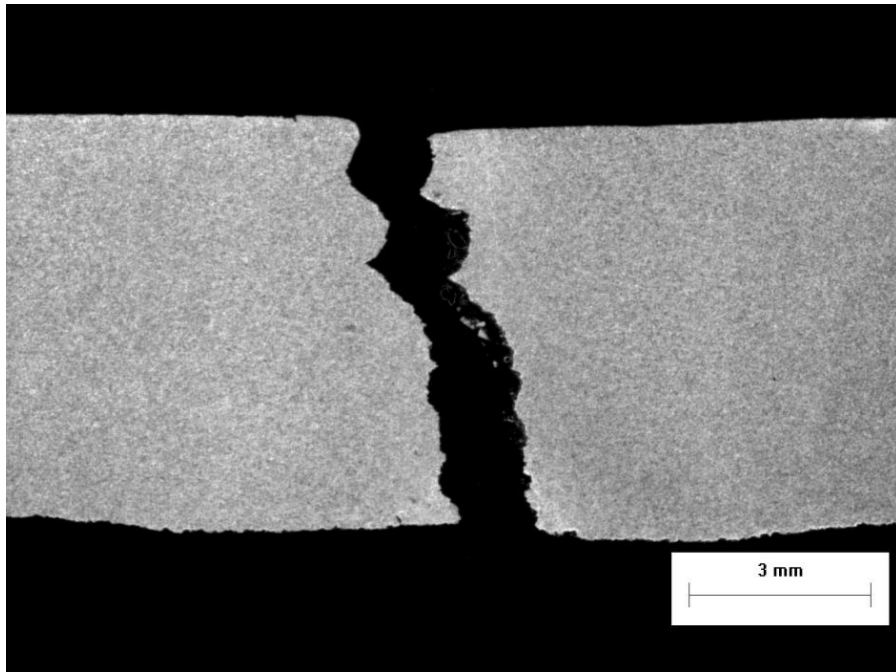
Figure 25

Other hook cracks were apparent along the length of the fracture, a typical example of which is shown in Figure 25.

Photograph of a typical hook crack found along the rupture.

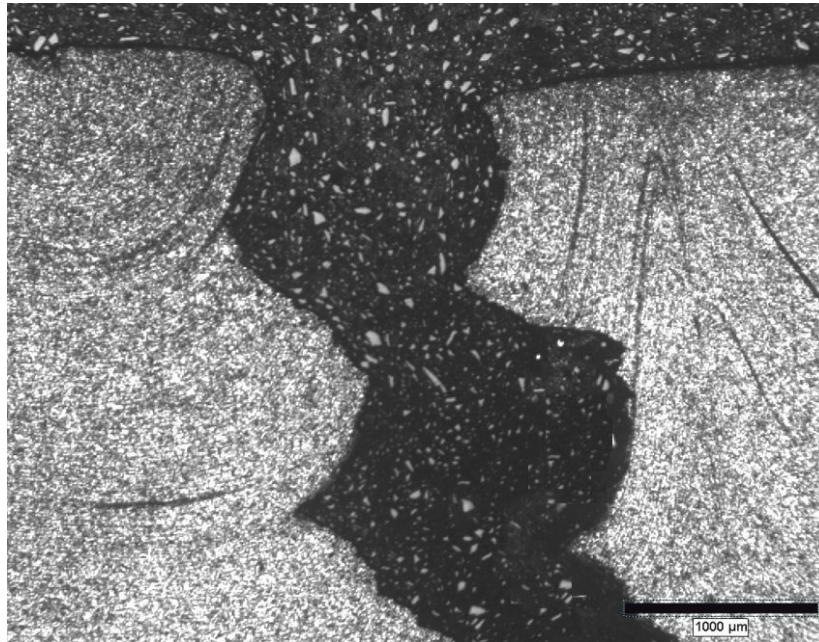
Figure 26 shows the sections from the hook crack at the apparent failure origin, and Figure 27 shows the sections from the hook crack shown in Figure 25.

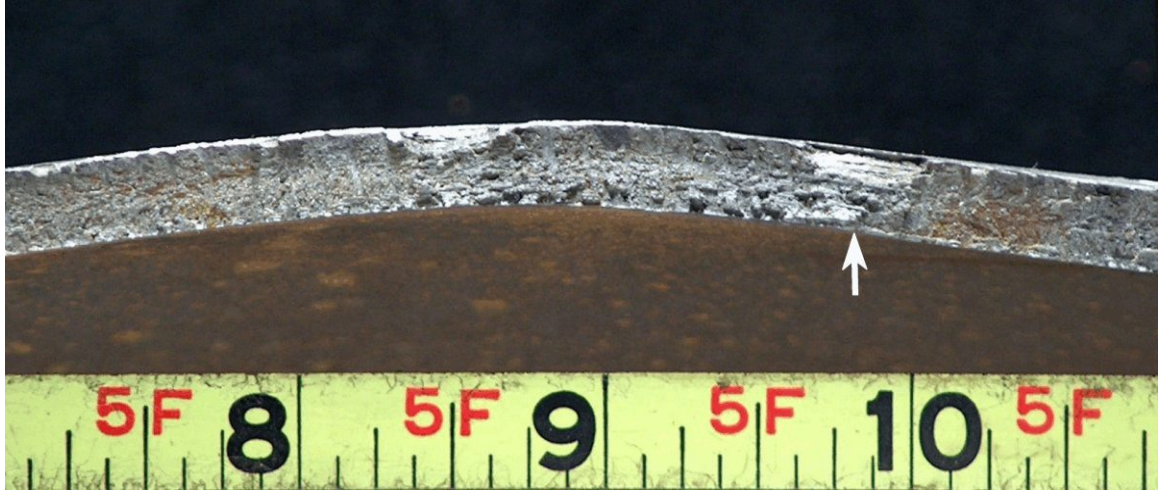
The rupture in Joint No. 6106, shown in Figure 36, extended from 2 feet, 5 inches to 8 feet, 3 inches. There was a bulge near the middle of the rupture and slight post-rupture mechanical damage at the outside surface at the bulge. Two small flaws were apparent on the fracture surface in the bulged area at which the fracture

Photograph showing the rupture in Joint No. 6106.

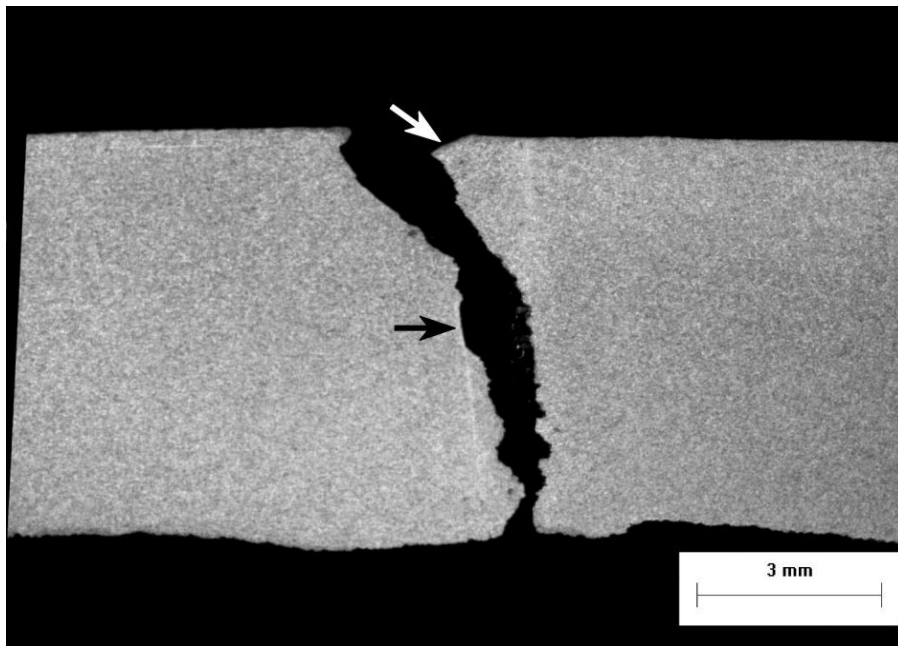
Joint No. 6106

may have initiated, which are shown in Figure 37. There was one reported inspection indication in the fracture length, at 4 feet, 6 inches, which appeared to be a hook crack and is shown in Figure 38. This was the deepest flaw in this joint, and was 0.15 inch deep, which is 55 percent of the measured wall thickness. At other locations the fracture surface was rough and irregular, with evidence of many small discontinuities.

Photograph showing the fracture surface at a reported PAUT indication. The arrow indicates a location from which a metallographic section was taken.

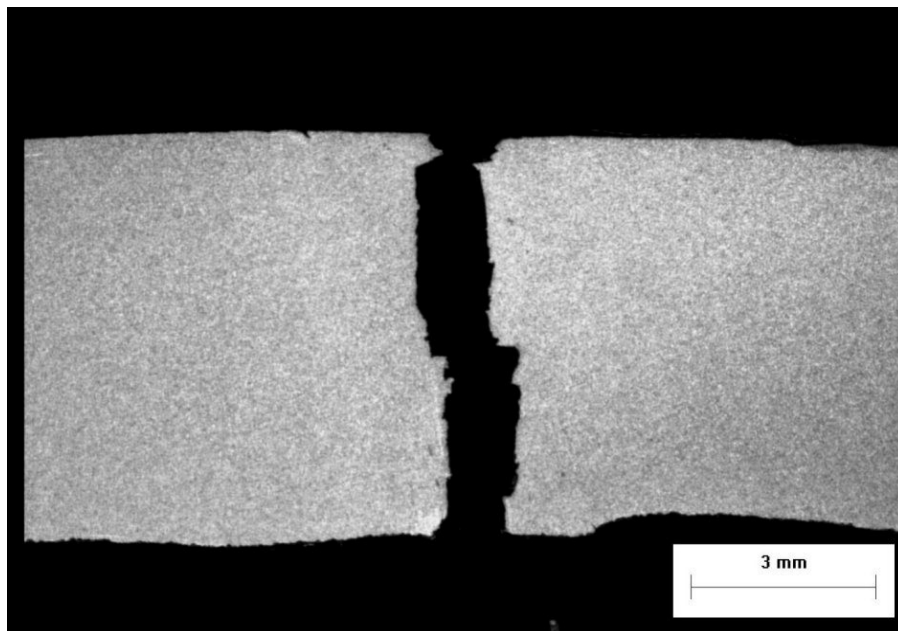
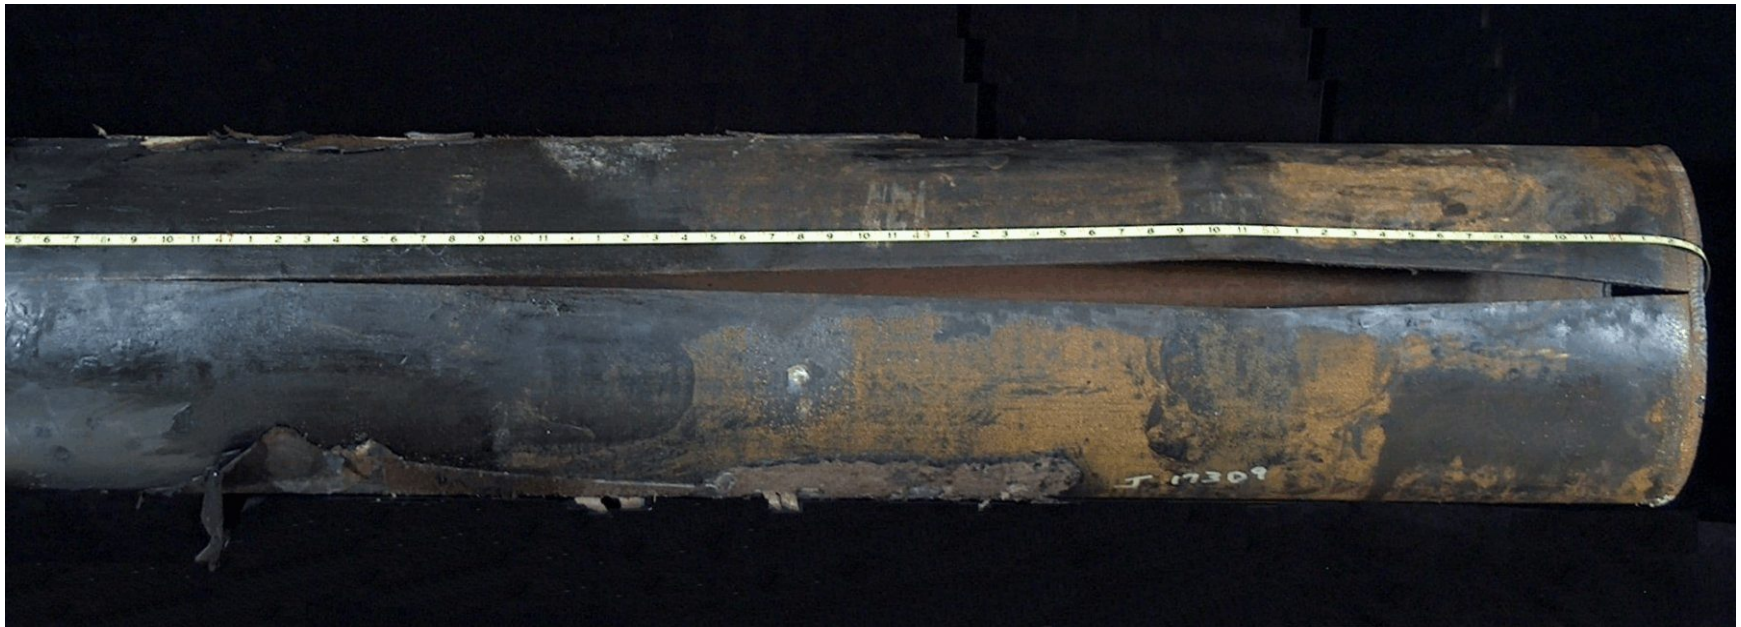
Matching transverse sections were taken from one of the apparent flaws at the bulge, and from the hook crack at the reported inspection indication. Figures 39 and 40 show the sections from the flaws indicated by the arrows in Figure 37 and 38, respectively. Neither specimen showed a heat-affected zone, indicating they were from Lone Star Steel pipe. The sections at the bulge, Figure 39, did not match very well because of the mechanical damage on one side, white arrow. The fracture at this location appeared to have started along the weld line, black arrow, and broke at an angle across the base metal at the inside surface.

The part of the fracture in the specimen from the hook crack, Figure 40, was relatively straight, but at higher magnification much of the fracture was along the fiber lines next to the weld. However, the fiber lines were not as pronounced as were those in some of the other Lone Star Steel pipe.

Matching transverse sections from the locations indicated by arrows in Figures 37 and 38, respectively. The white arrow in Figure 39 indicates mechanical damage, and the black arrow indicates the weld line.

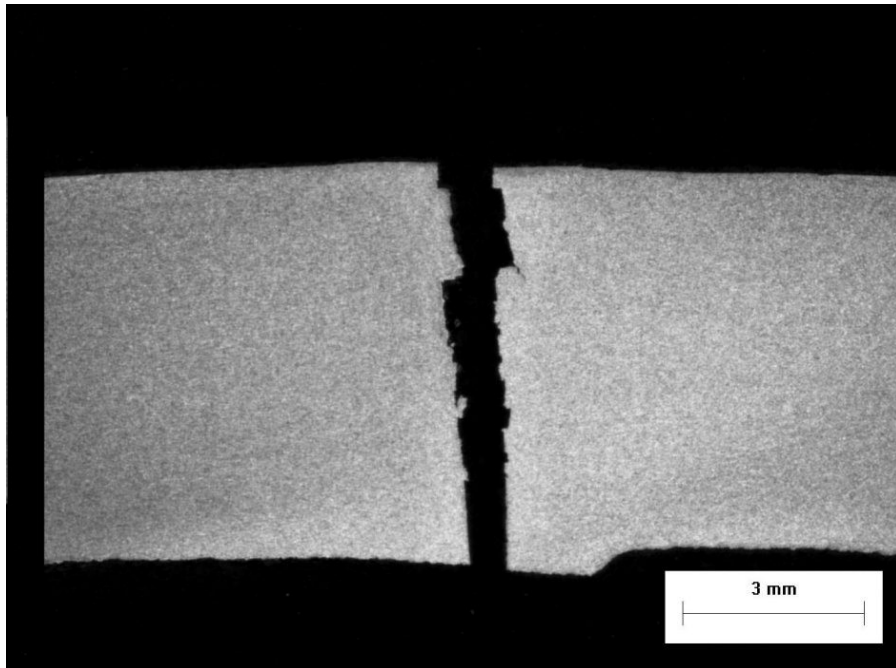
Joint No. 2796

Figure 42 shows the hook crack at the outside surface at the failure origin, and Figure 43 shows typical black spots at the inside surface.

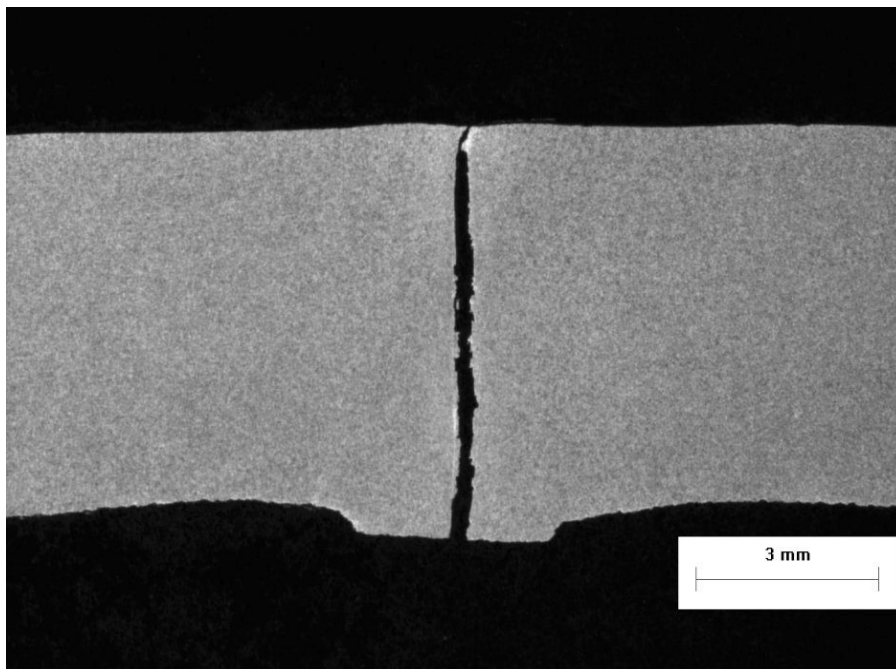
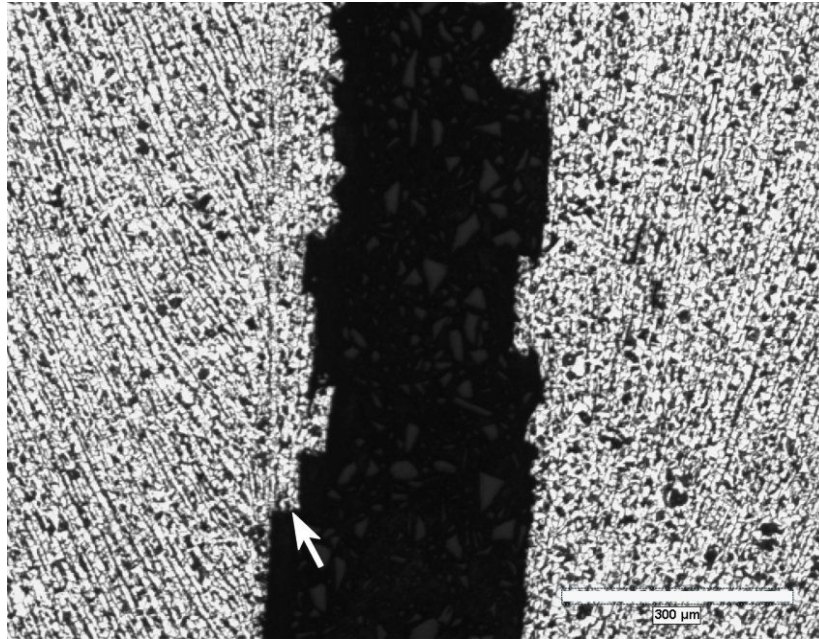
Matching transverse sections from the hook crack and one of the black spots shown in Figures 42 and 43, respectively.

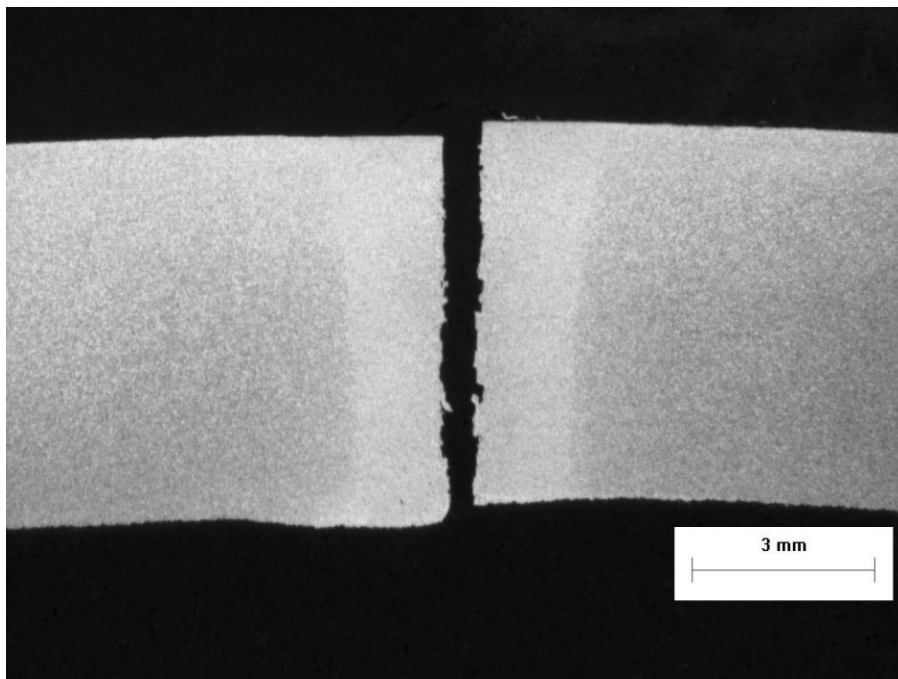
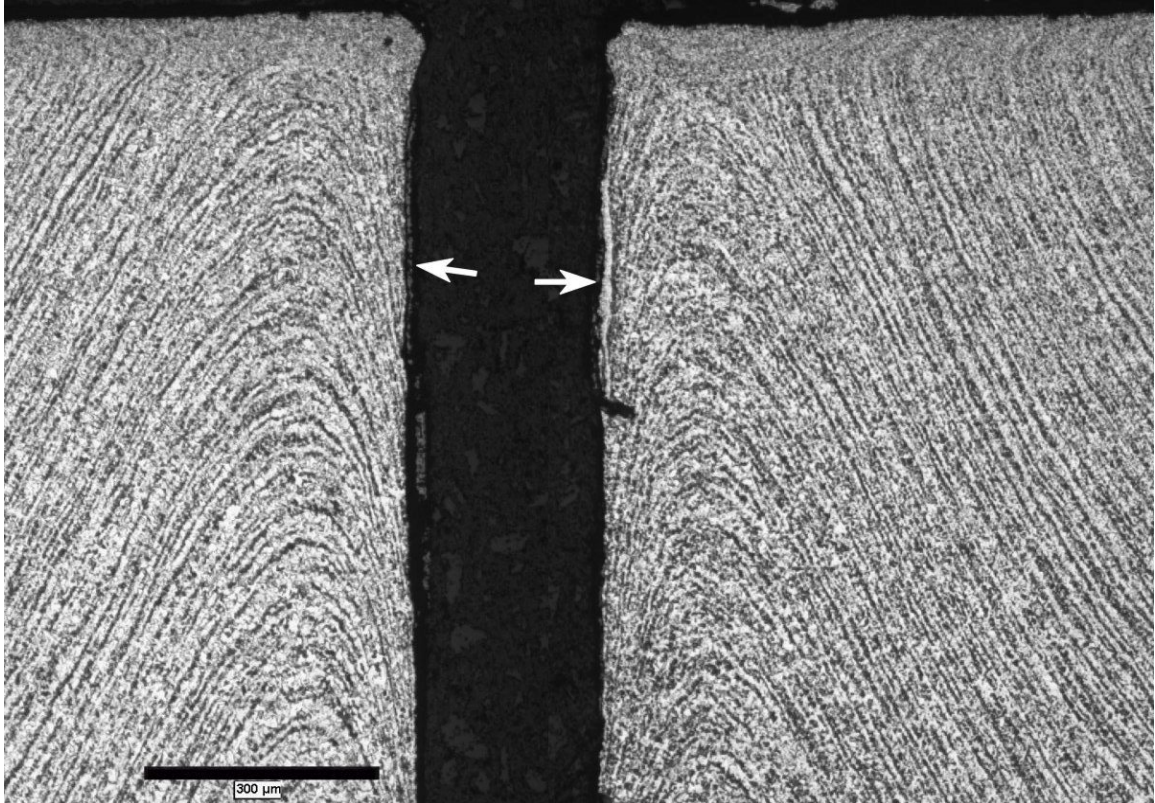
Matching transverse sections from the large black spot shown in Figure 49 and the hook crack shown in Figure 51, respectively.

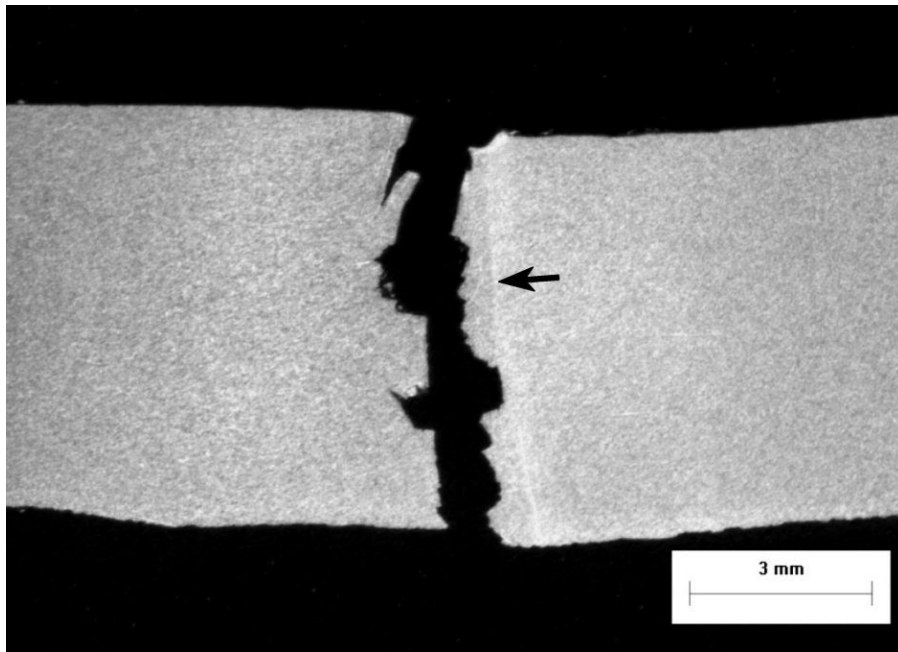
Joint No. 2753

Figure 57 shows a typical location with hook cracks and multilayer fracture surface, and Figure 58 is a closer view of part of the fracture.

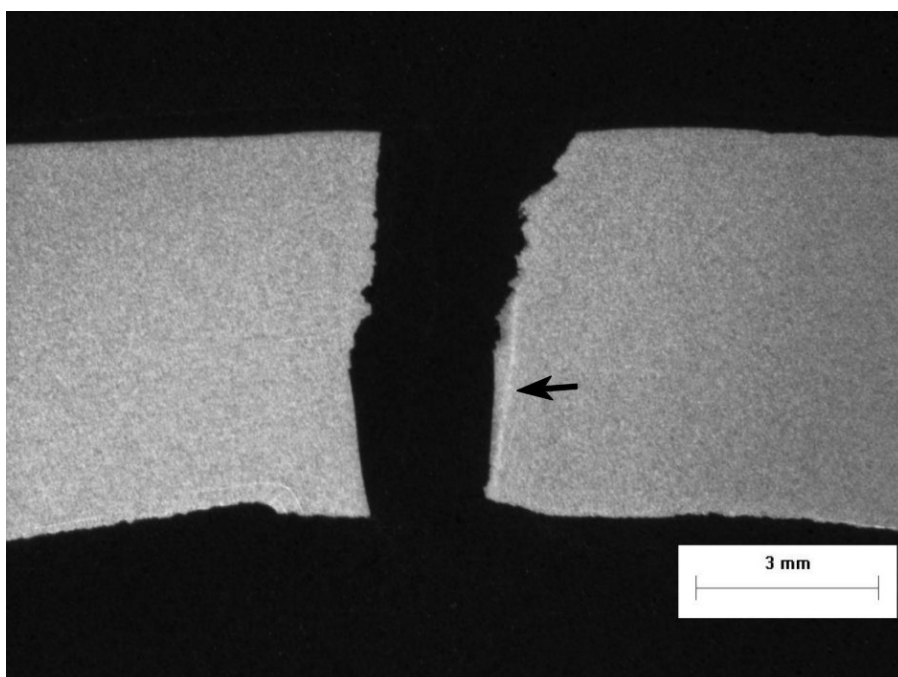
Joint No. 4013

Figure 61 shows a hook crack on the inside surface at the failure origin, and Figure 62 shows the fracture at the location of a reported USCD indication (45 feet, 7 inches).

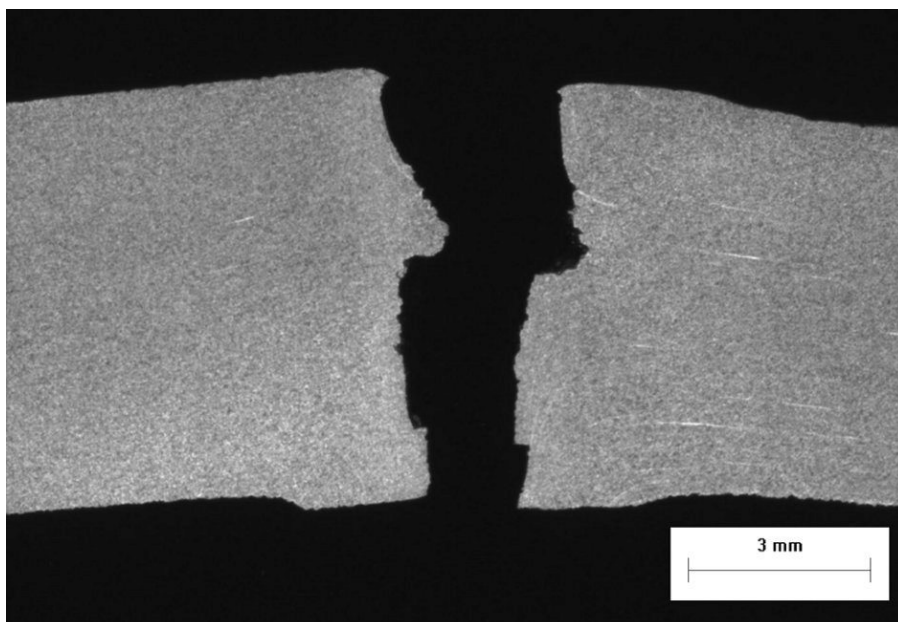
Joint No. 6418

Photograph showing a typical location with hook cracks and brittle fractures.

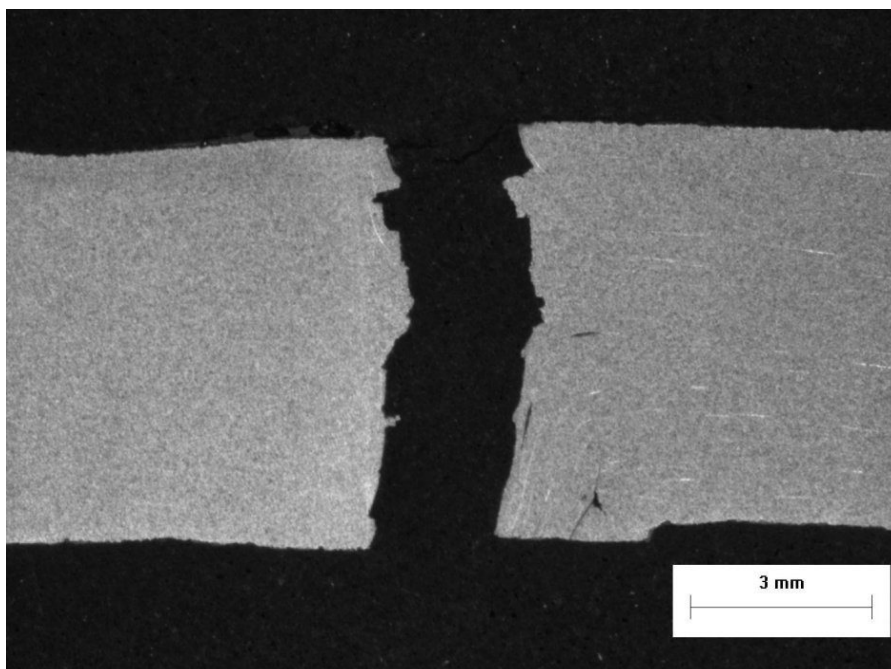
Joint No. 10737

Photographs showing hook cracks on the fracture surface at the other two reported USCD indications.

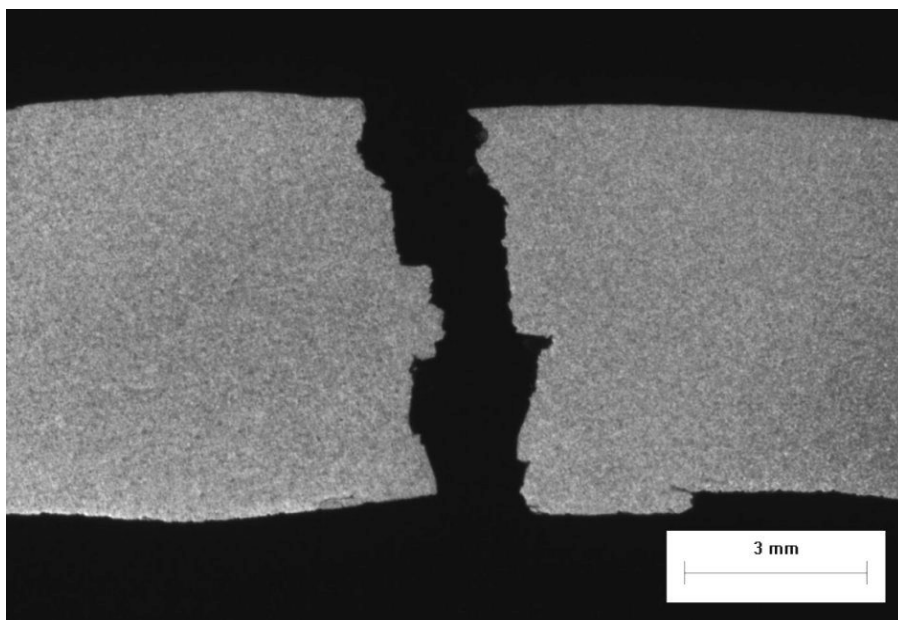
Joint No. 7757

Photograph showing a fracture area with black spots at the inside and stitching along the outside surface.

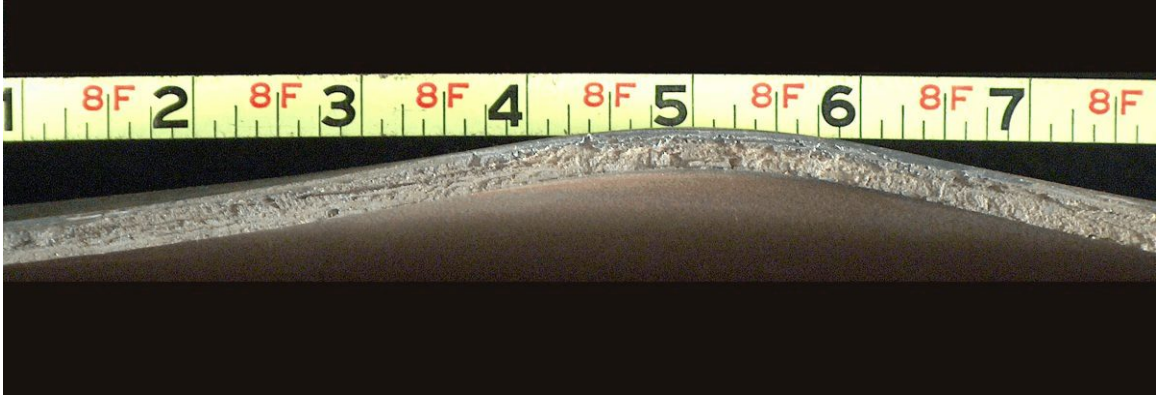
Figure 77

Joint No. 3897, shown in Figure 77, fractured for a length of 4 feet, 10 inches. The apparent fracture origin was at a hook crack at a bulge at the middle of the rupture.

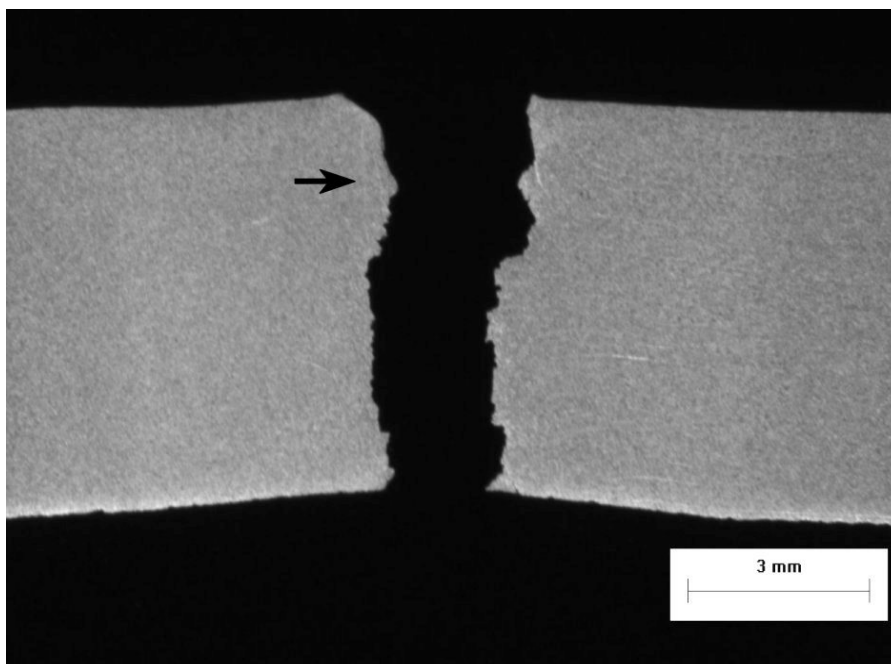
Joint No. 3897

Figure 78 shows the fracture at the failure origin, and Figure 79 shows a typical area of brittle fracture and hook cracks.

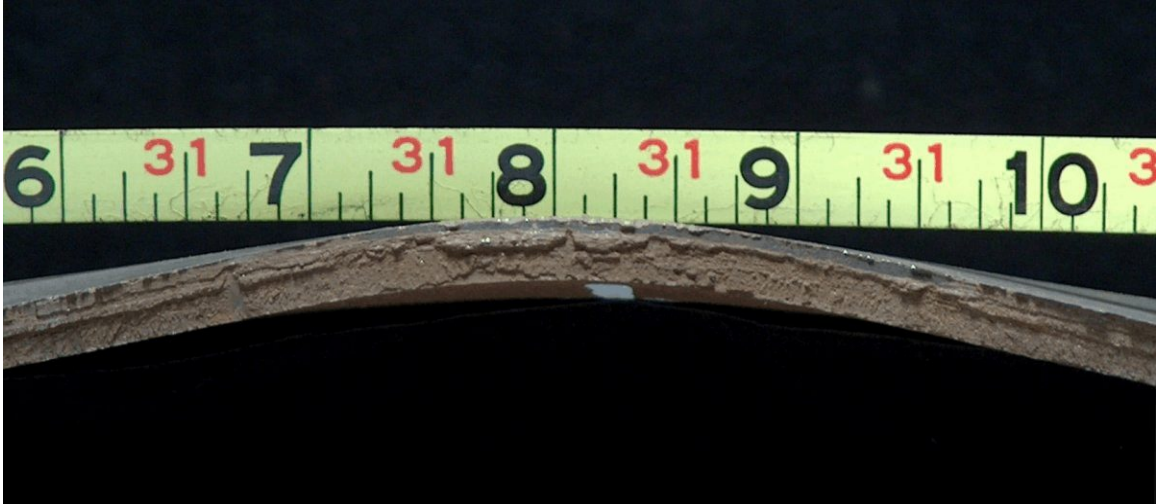
Figure 84

Photograph of the rupture in Joint No. 3645.

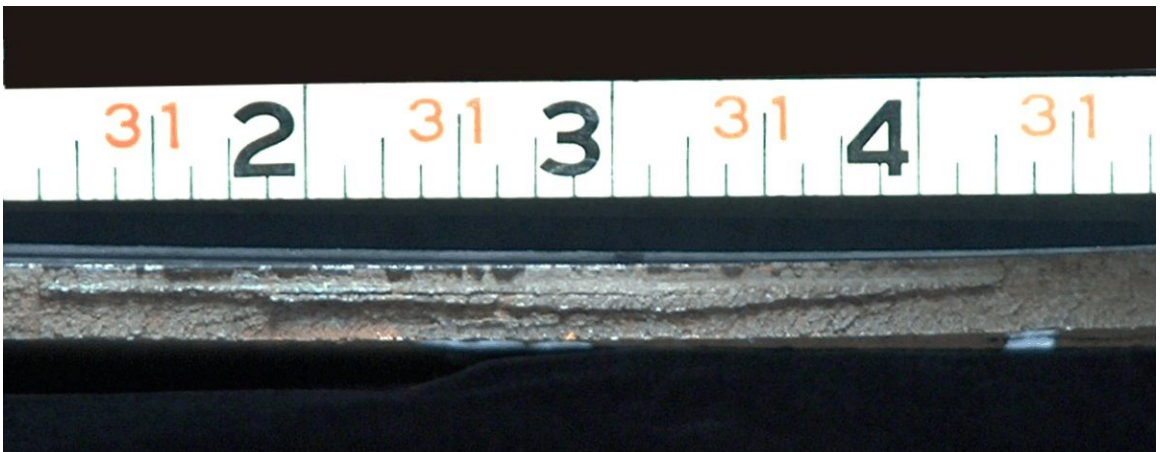
Figure 85

Photograph of a hook crack at the outside surface at the failure origin.

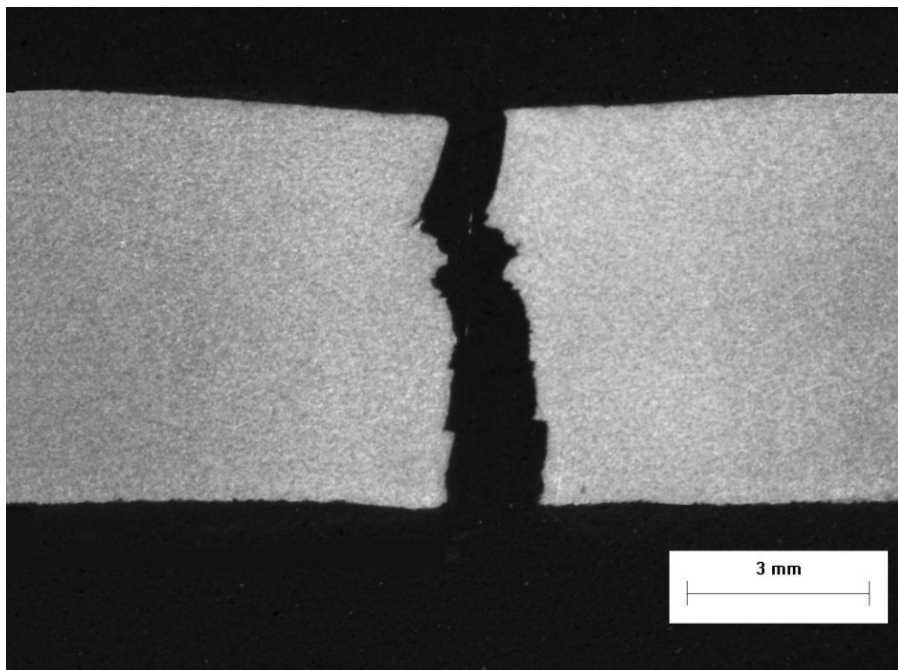
Joint No. 6005

Photograph showing a hook crack at the fracture origin.

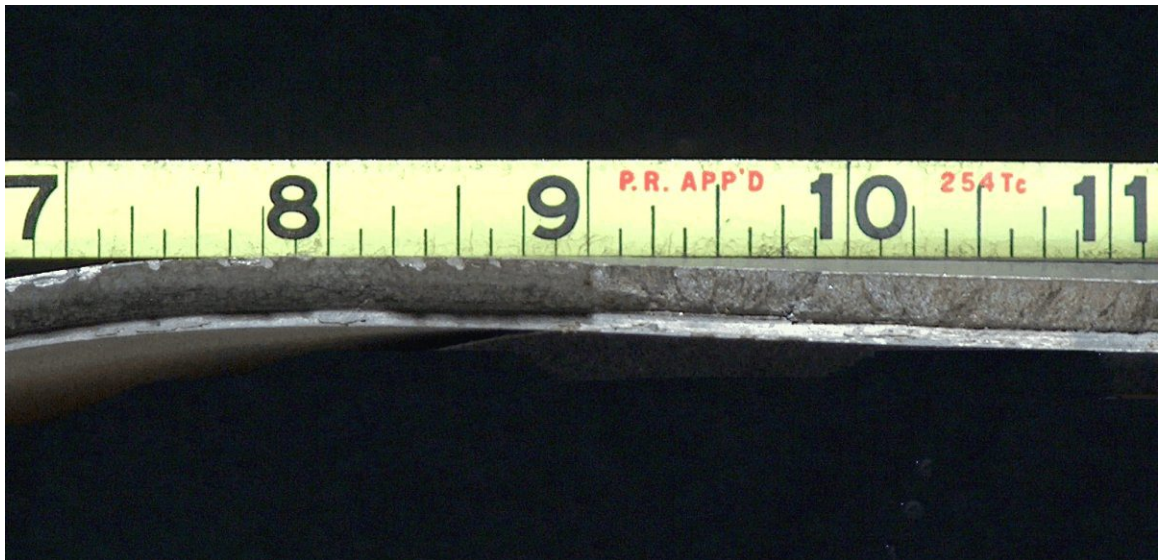
Figure 95

Photograph showing the rupture in Joint No. 7634.

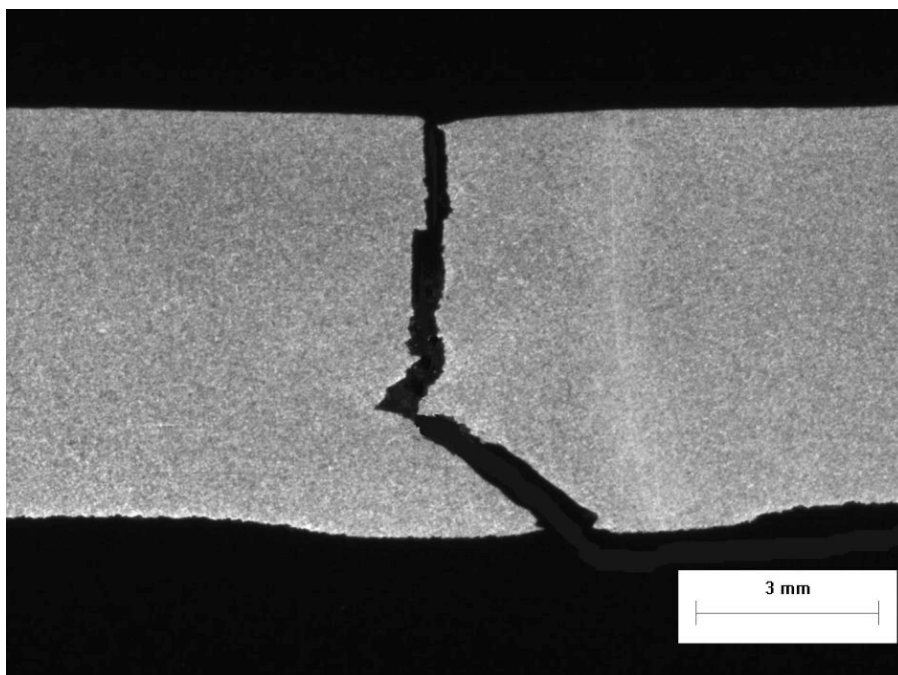
Figure 96

Photograph showing a large hook crack at the fracture origin.

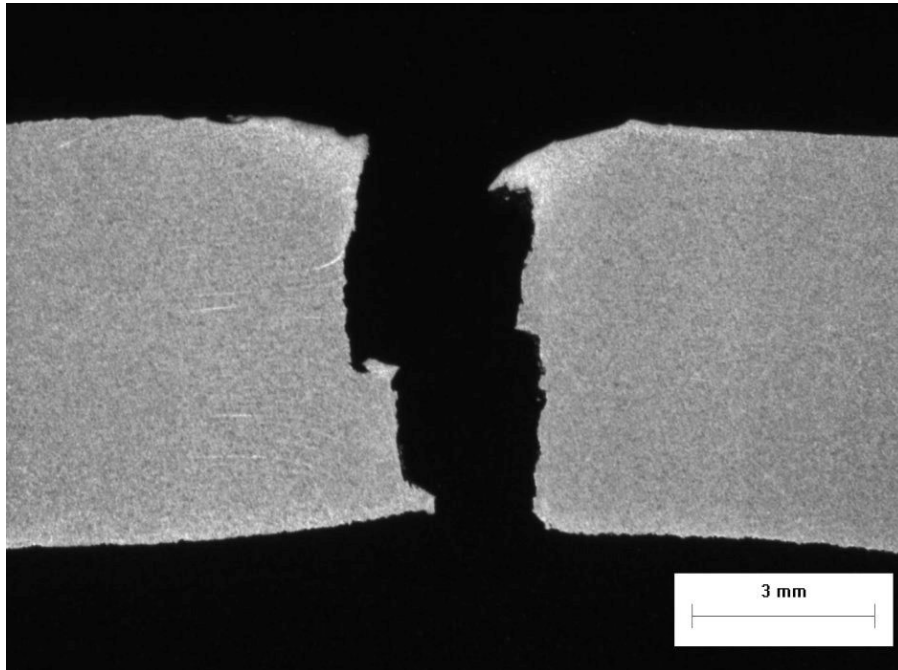
Joint No. 386

Photograph showing a hook crack at the likely failure origin.

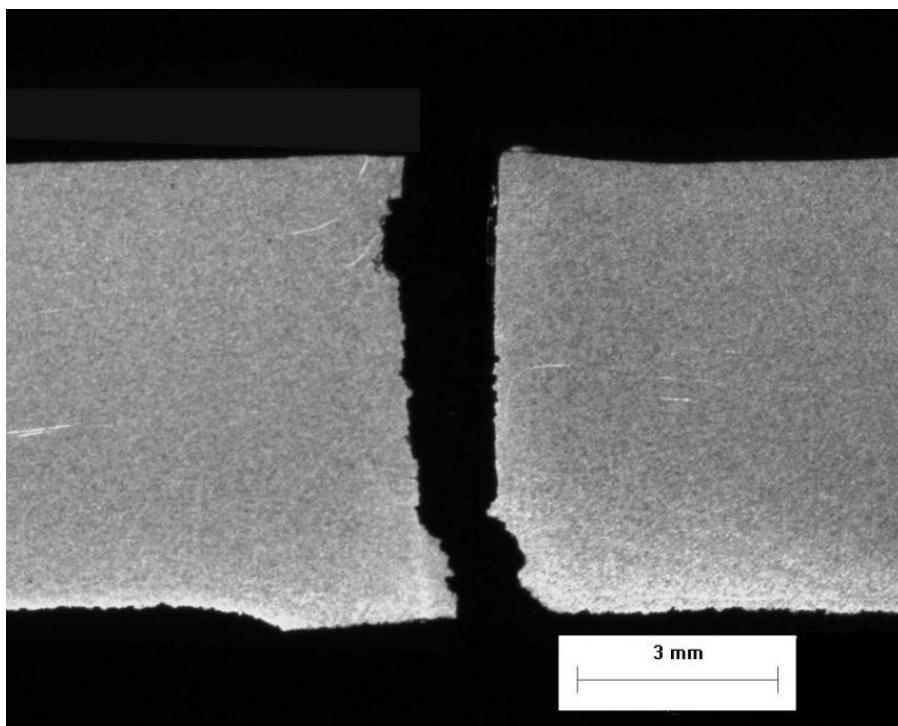
Joint No. 8769

Figure 106 shows a hook crack, multilayered fracture and black spots at a bulge near the center of the rupture, and Figure 107 shows the deepest flaws, arrows, found along the rupture.

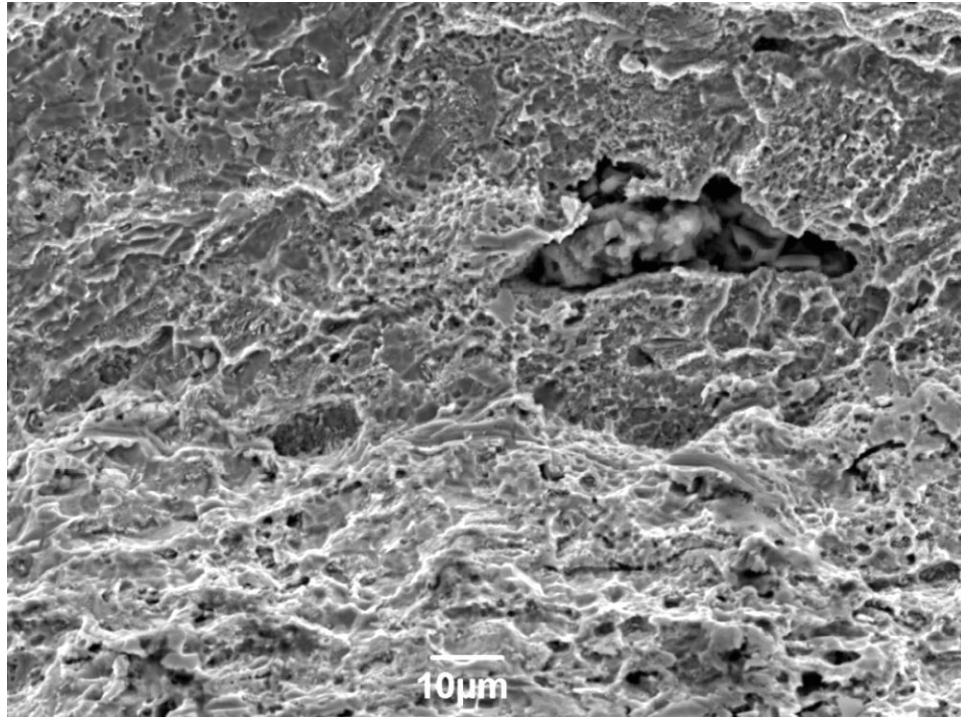
Macrograph of the failure origin of Joint No. 332. The boxes indicate the locations of Figures 110 and 111.

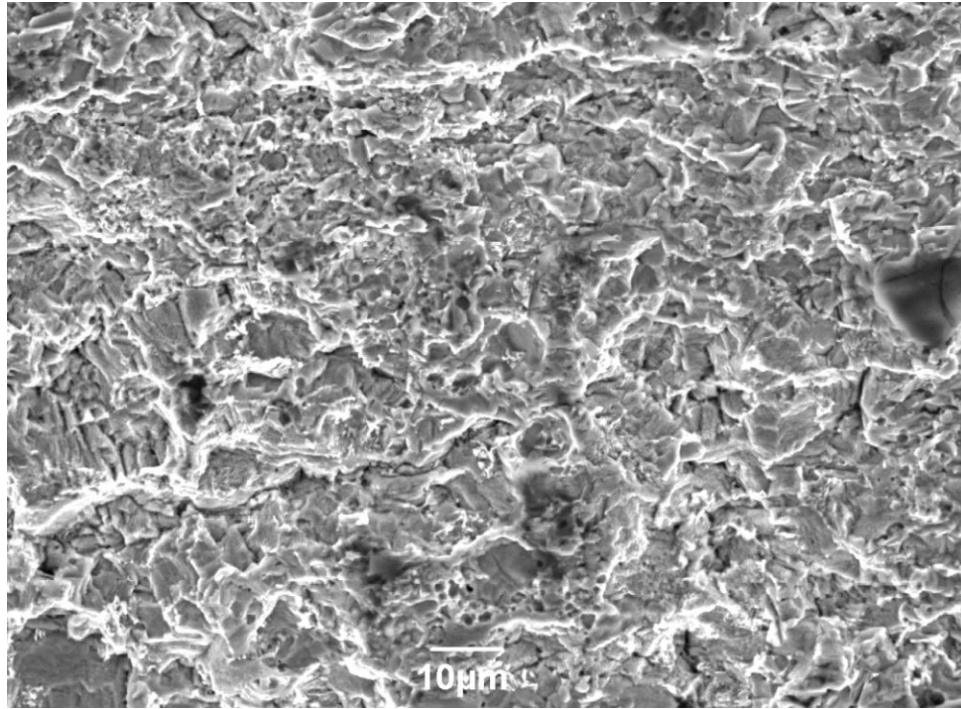
Macrograph of the area to the right of the failure origin in Joint No. 332.
